Zimmer®
Prolong®
Highly
Crosslinked
Polyethylene

Improved polyethylene performance

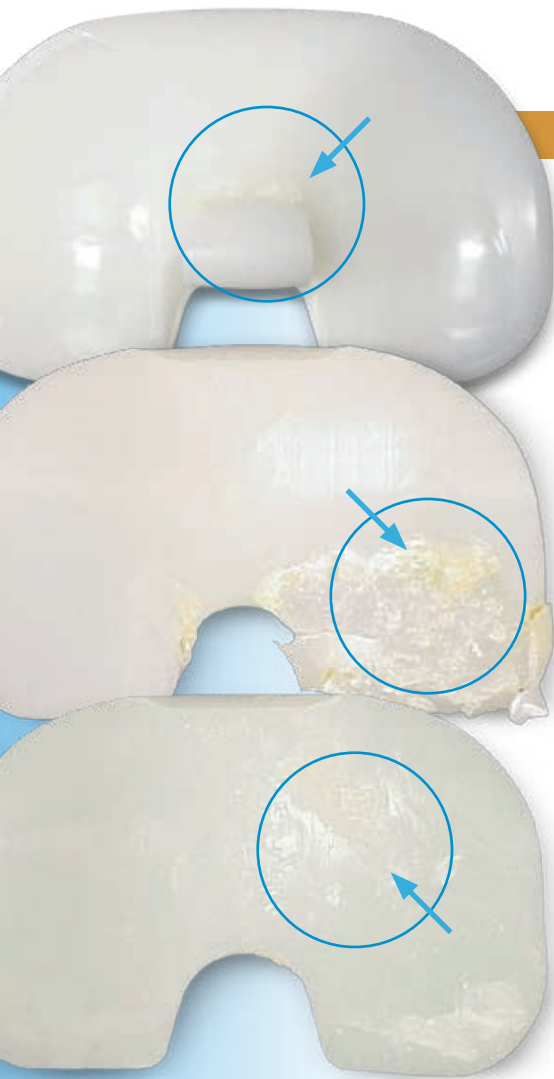
Typical wear associated with conventional polyethylene knee inserts.

While TKA has proven successful, tibial insert wear and damage are often cited as primary causes for an estimated 63,000 revision knee surgeries each year.^{1,2,3,4} One recent study identified polyethylene wear as the most common cause for knee revisions.⁵ In this study, 44% of knees revised more than two years after the index arthroplasty were directly attributed to polyethylene wear.

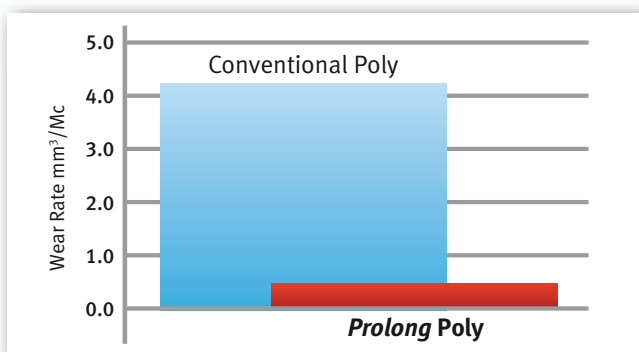
BACKSIDE VOLUMETRIC WEAR RATES

In joint simulator testing, conventional polyethylene exhibited more backside wear compared to Prolong polyethylene.^{8,11}

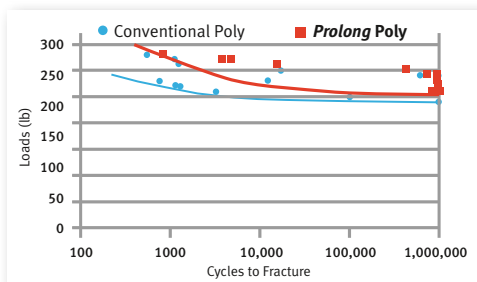
PS POST FATIGUE STRENGTH TEST

PS post fatigue strength testing concluded that the *Prolong* polyethylene PS post performed at least as well as the conventional polyethylene post.

Testing has shown that the Prolong polyethylene PS post is at least as strong as the conventional polyethylene post.

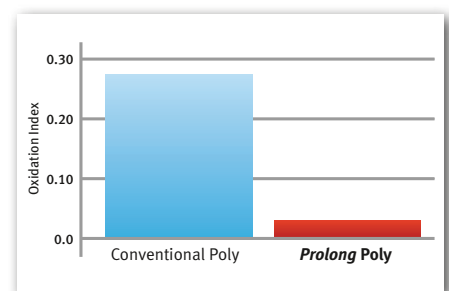
OXIDATION

In laboratory testing Prolong polyethylene effectively resisted oxidation.
